# ADVERSE HIGH RAIL PROFILES: IDENTIFICATION, RISKS AND A SOLUTION

FRA Track Safety Symposium  
St. Louis, MO  
April 6, 2022

*Brad Kerchof*  
*Advanced Rail Management*  
*Norfolk Southern Railway (retired)*

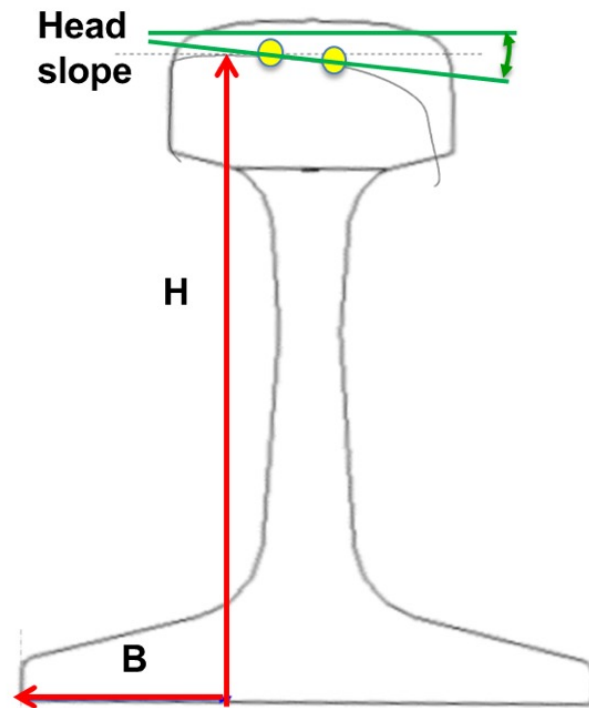
➤ Head slope is the angle between horizontal and a line defined by two points one-half inch on either side of rail centerline

- ❑ Steeper slope -> more likely that wheels will run on the field side
- ❑ Threshold for concern:  $> 5^\circ$

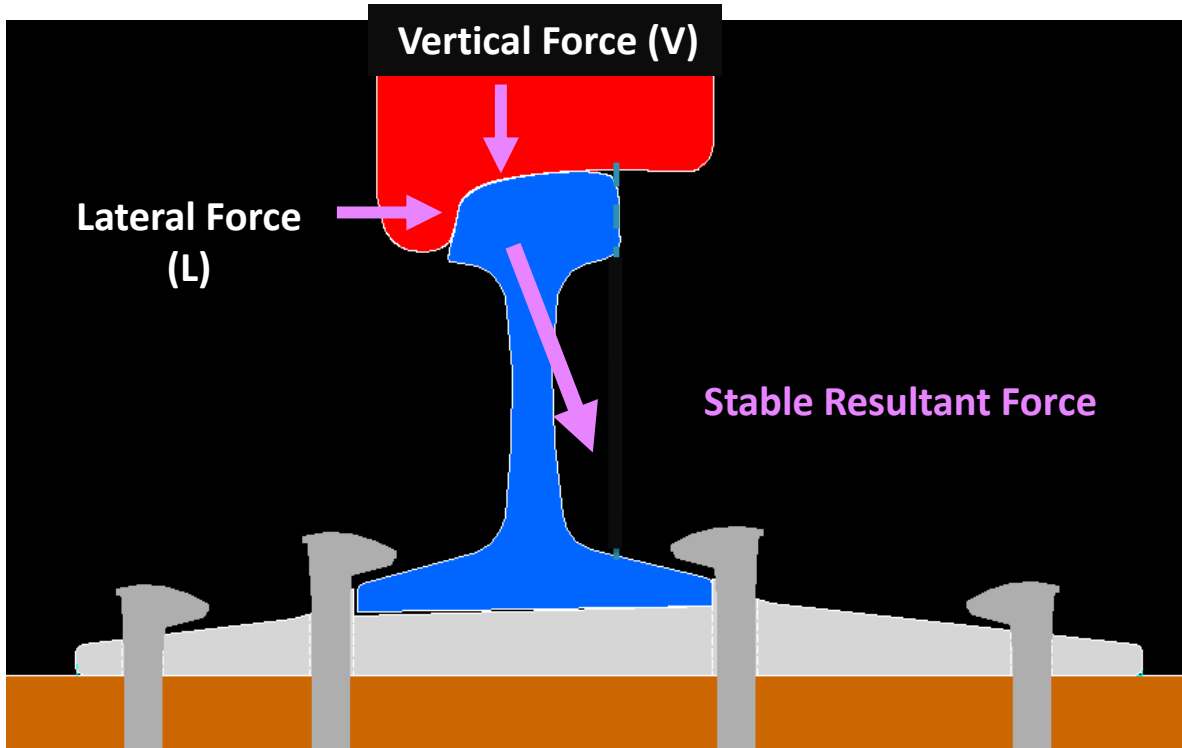
### Stable condition

- Lateral & vertical forces produce a resultant directed inside the rail base
- The rail will not roll outward

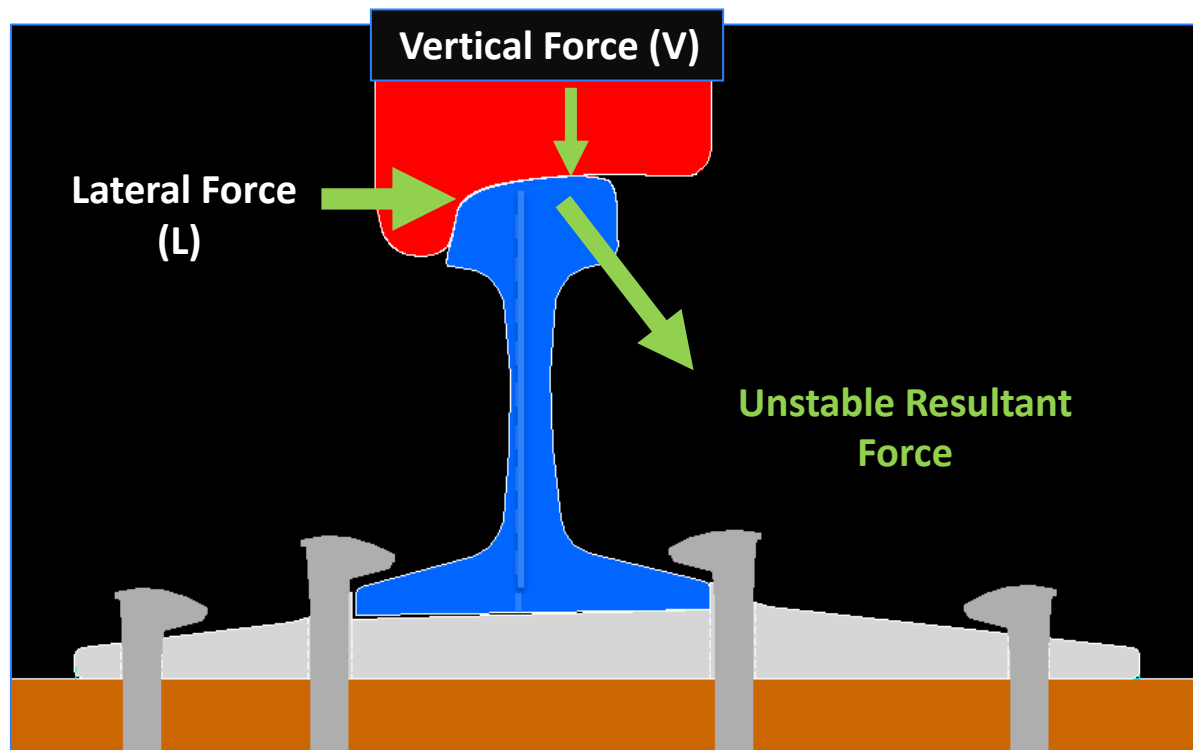
### Unstable condition

- Vertical force has shifted toward the field side
- Lateral force has increased
- Lateral & vertical forces produce a resultant directed outside the rail base
- An unrestrained rail will tend to roll outward

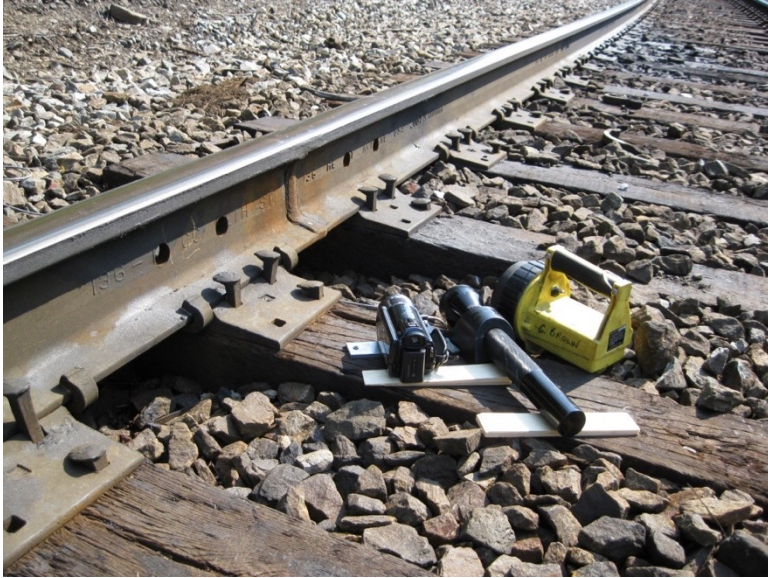
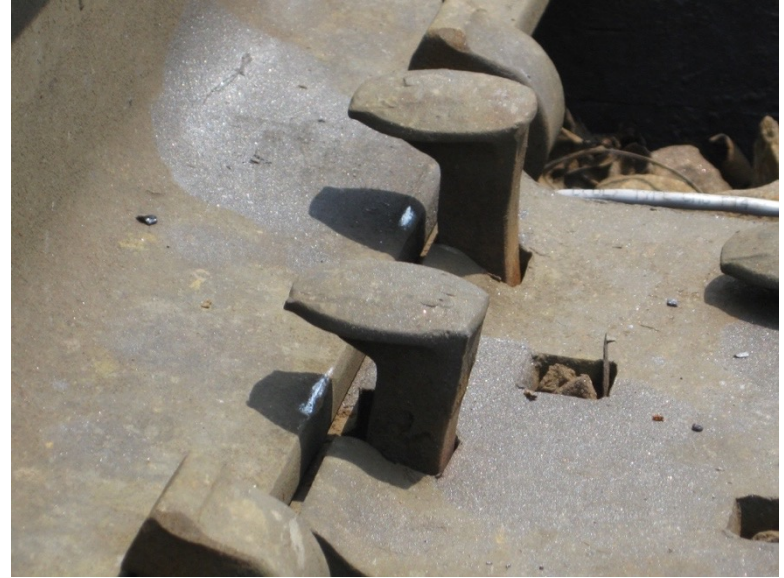
Same  $8^\circ$  curve; low rail still has conventional tie plates & cut spikes

Anything to be worried about?

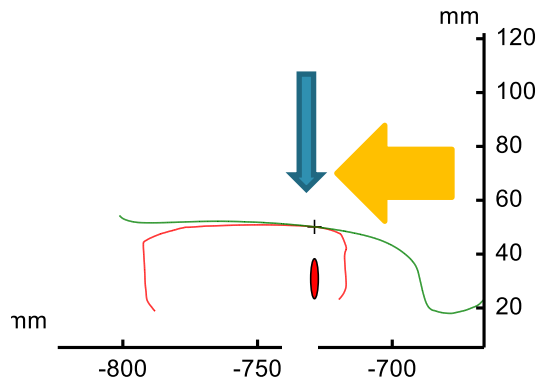
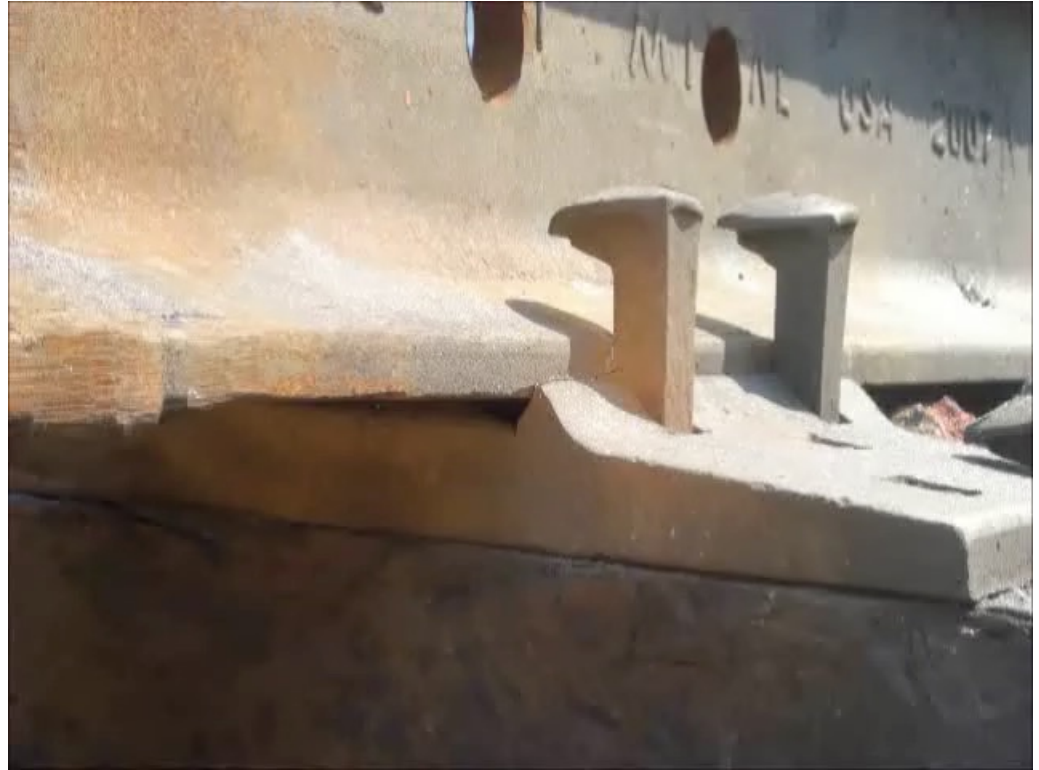
Because of the change in wheel contact on the high rail, the low rail was also subjected to higher lateral forces

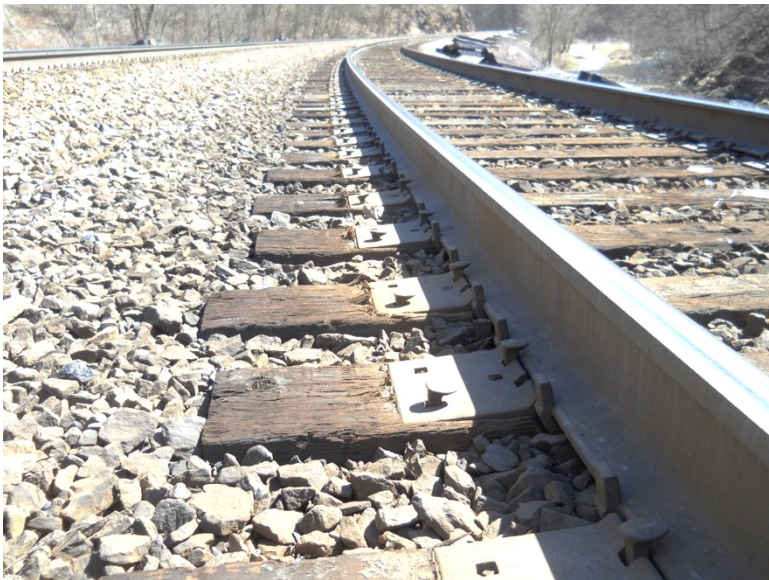
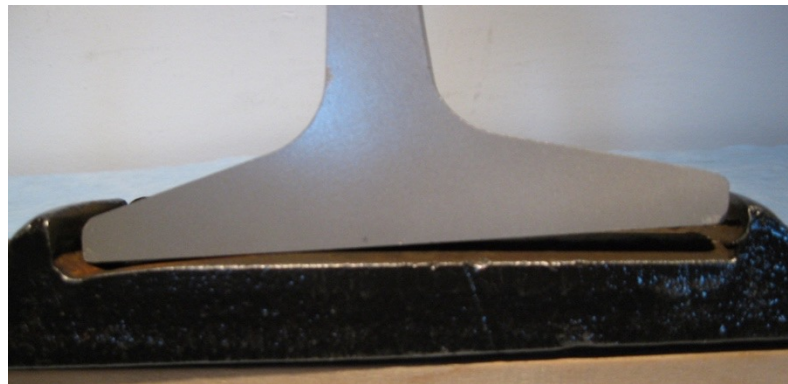
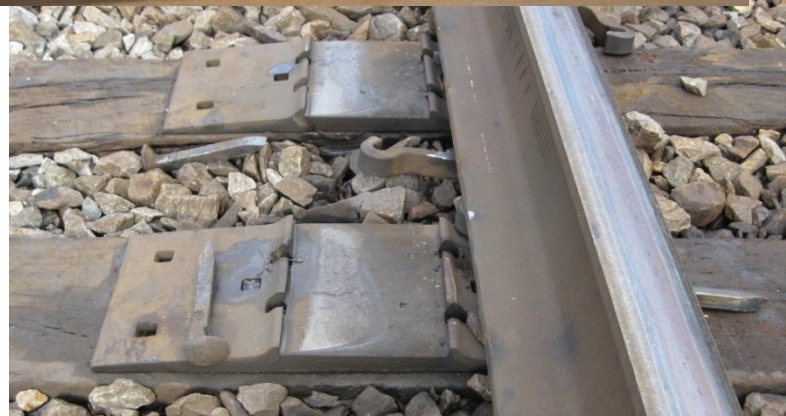
Primary reason: Grinding canted rail

Canted rail (on wood ties) is caused by plate-cut ties or worn tie plate rail seats

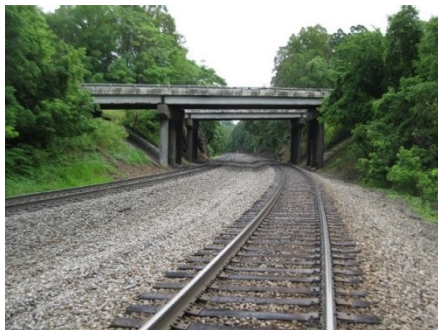
**Pre-grind:** Primary contact band is on the field side  
Side wear 6/16", cant 1.5°, B/H 0.34, head slope 8°

**Post grind:** Wheel contact shifted toward gage side

Speed 6 mph

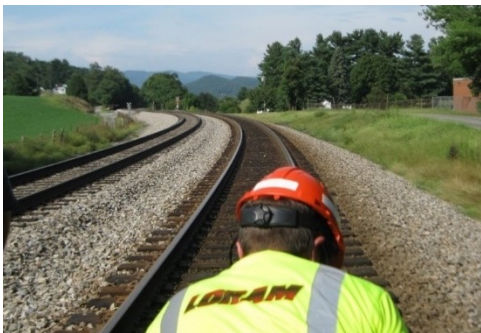
**Post grind:** After 3 passes, the primary wheel contact band is more concentrated on the gage corner (red arrow).

Field-side contact by hollow-tread wheels is still apparent (yellow arrow).
